# Debris/Ice/TPS Assessment and Integrated Photographic Analysis for Shuttle Mission STS-54

(NASA-TM-107558) DEBRIS/ICE/TPS  
ASSESSMENT AND INTEGRATED  
PHOTOGRAPHIC ANALYSIS FOR SHUTTLE  
MISSION STS-54 Final Report, 12-21  
Jan. 1993 (NASA) 146 p

DEBRIS/ICE/TPS ASSESSMENT  
AND  
PHOTOGRAPHIC ANALYSIS  
OF  
SHUTTLE MISSION STS-54

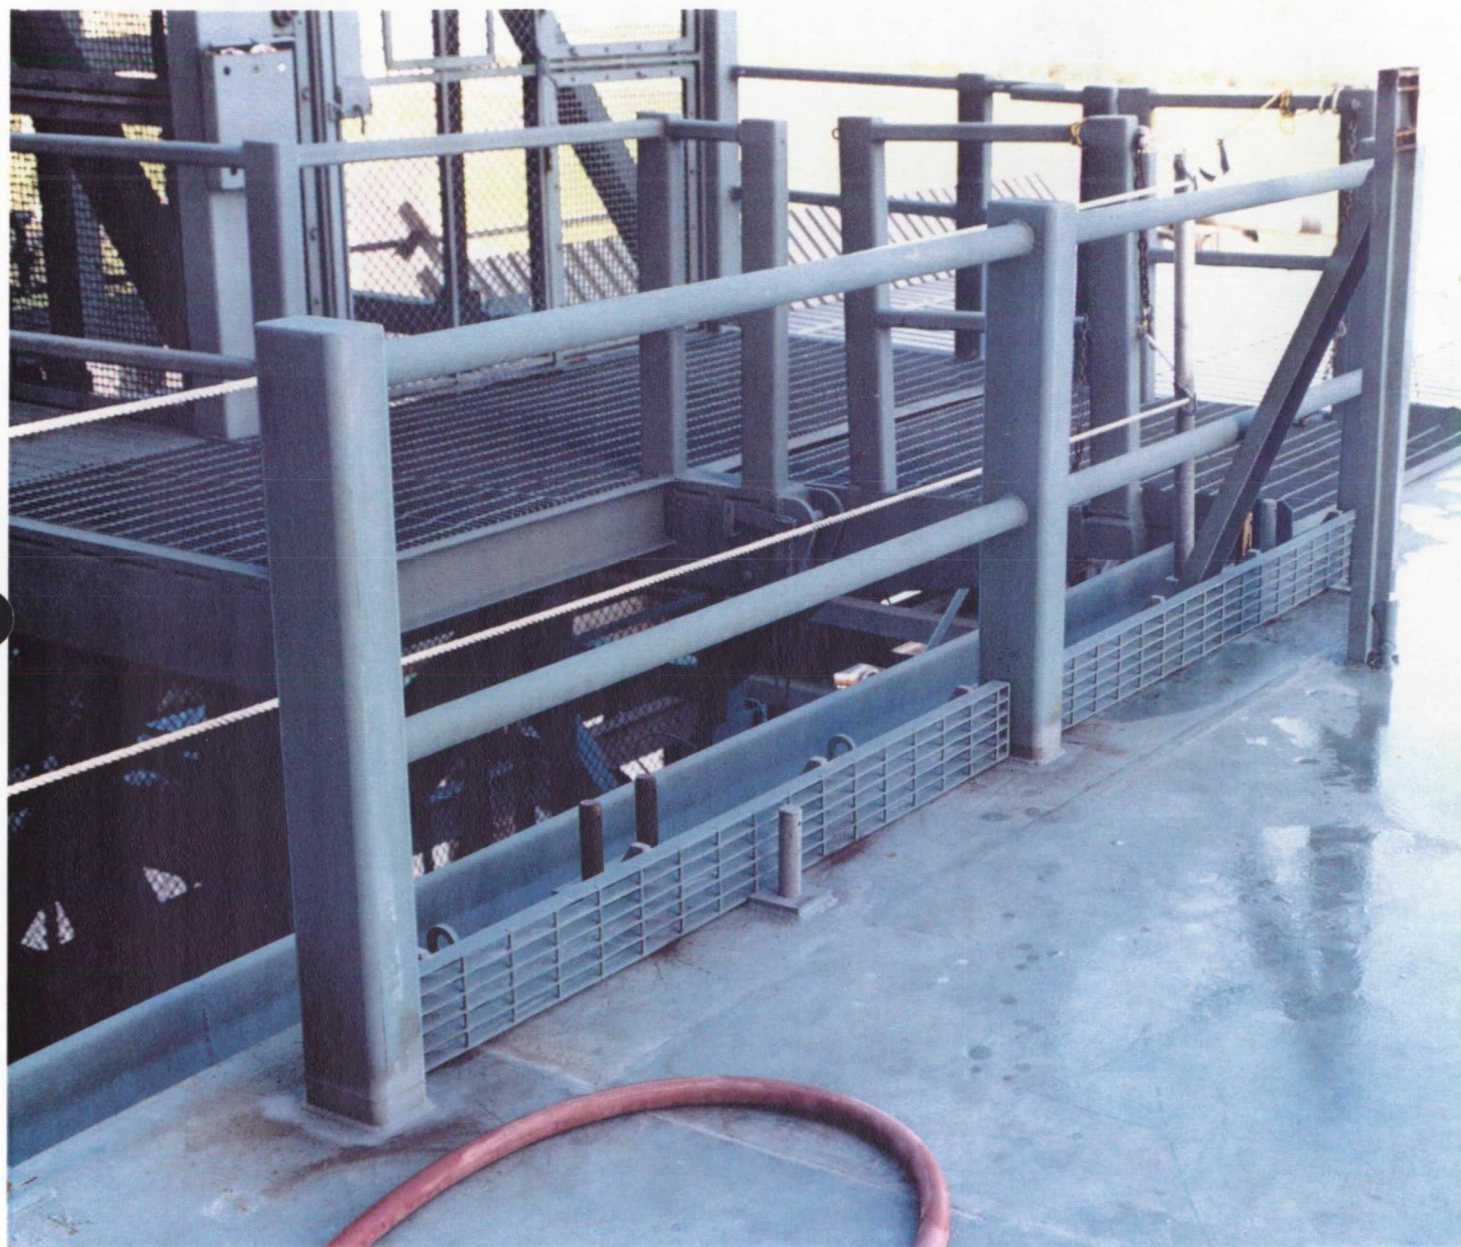
A metal washer, 1.125 inches in diameter, lay against Orbiter tile on top of the Orbiter Access Arm (OAA) inflated seal. After the washer was removed, a partial coating of white paint was found on the washer similar to that covering the nearby hypergolic fuel system access platform. No damage to Orbiter tiles was detected.

A metal washer lay against Orbiter tiles on top of the Orbiter Access Arm inflated seal. After removal, a partial coating of white paint was found on the washer similar to that covering the nearby hypergolic fuel system access platform. No damage to Orbiter tiles was detected.

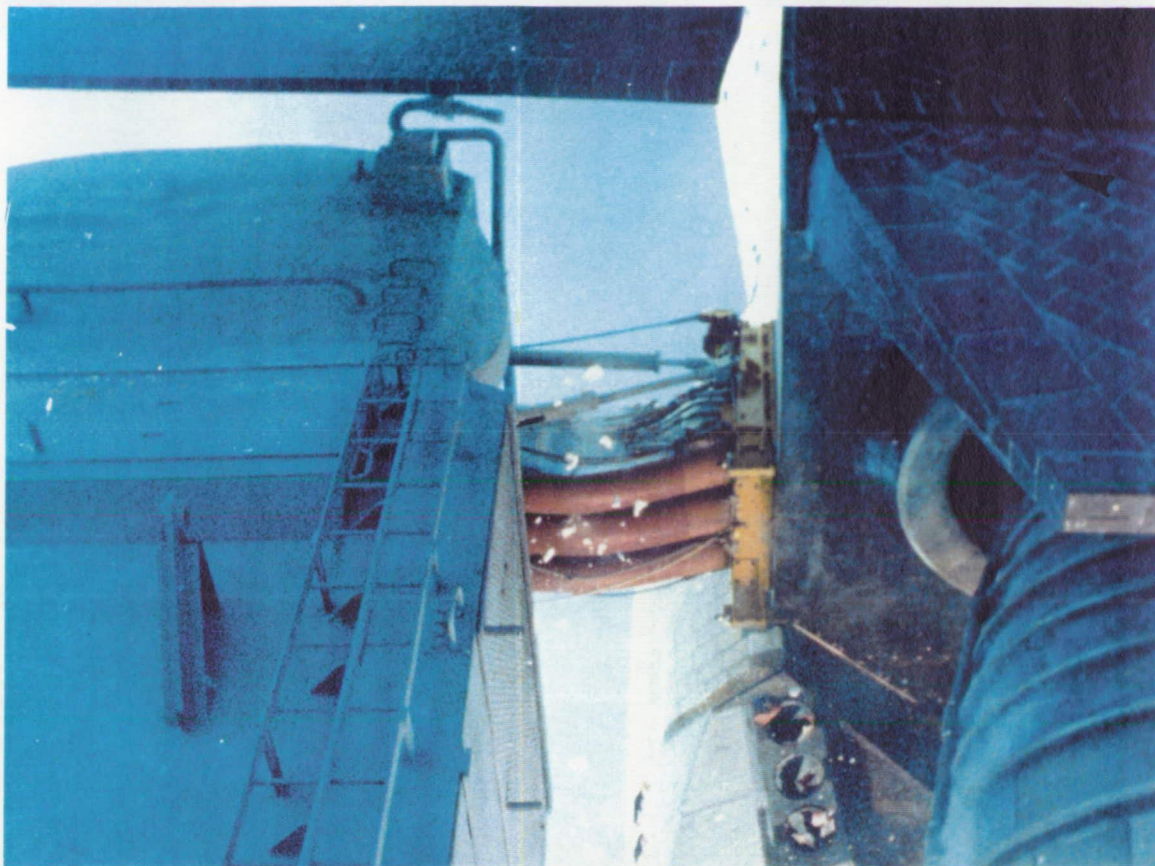
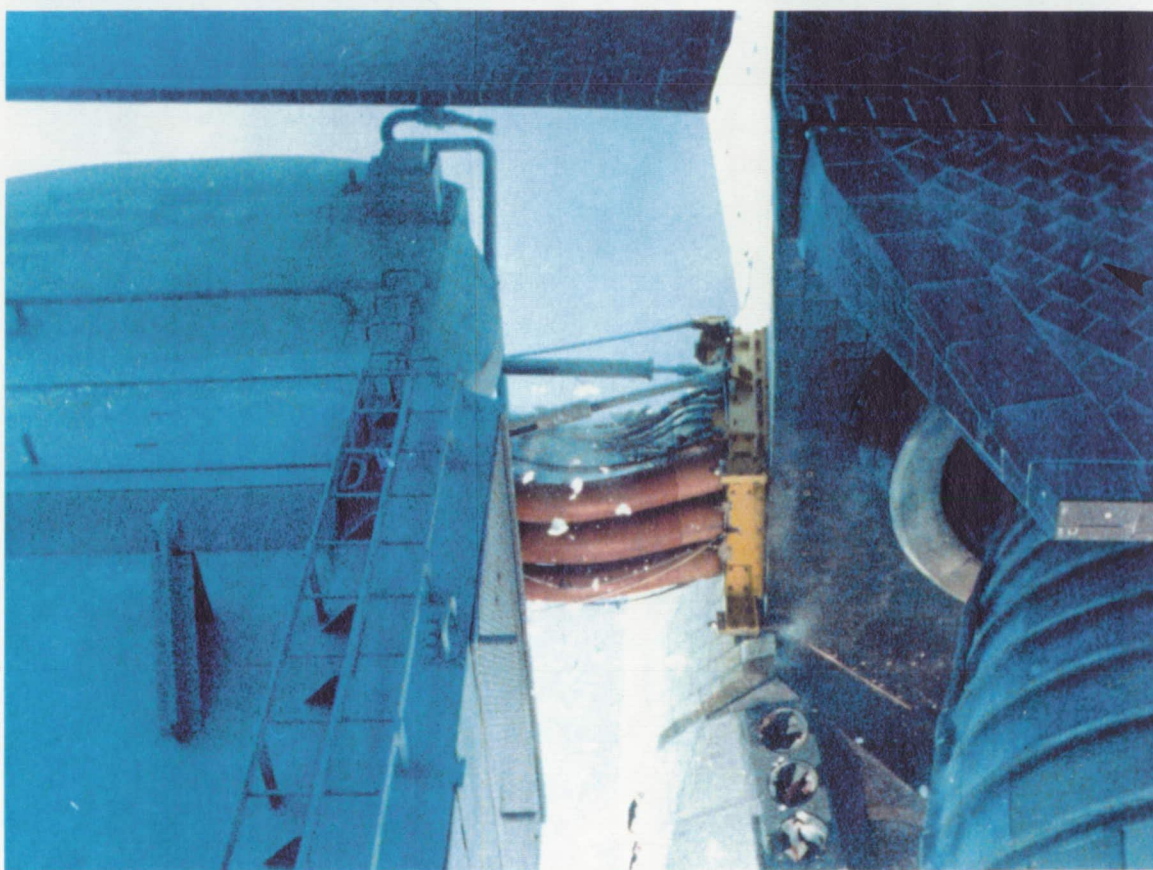
Green flashes, which may be indicative of copper contaminants, occurred in the SSME #1 plume during ignition

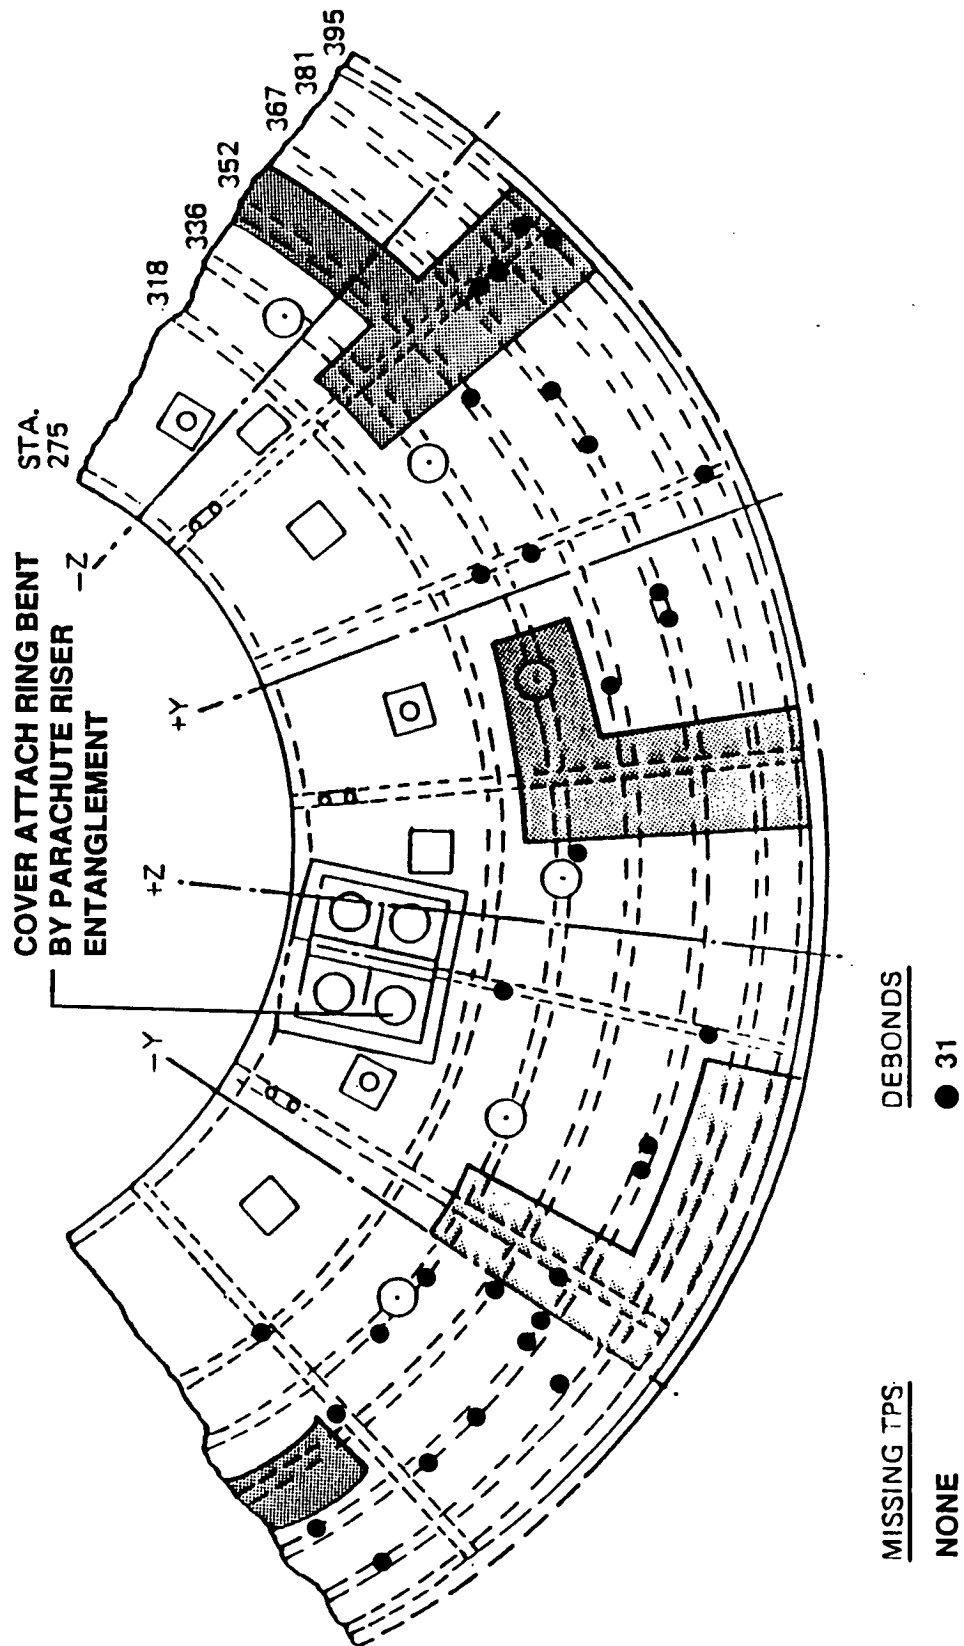
Figure 4. **RIGHT SRB FRUSTUM**

The RH frustum was missing no TPS, but had 31 MSA-2 debonds over fasteners. Minor localized blistering of the Hypalon paint had occurred along the 395 ring (Figure 4). All BSM aero heat shield covers were locked in the fully opened position though the lower left cover attach ring had been bent by parachute riser entanglement.

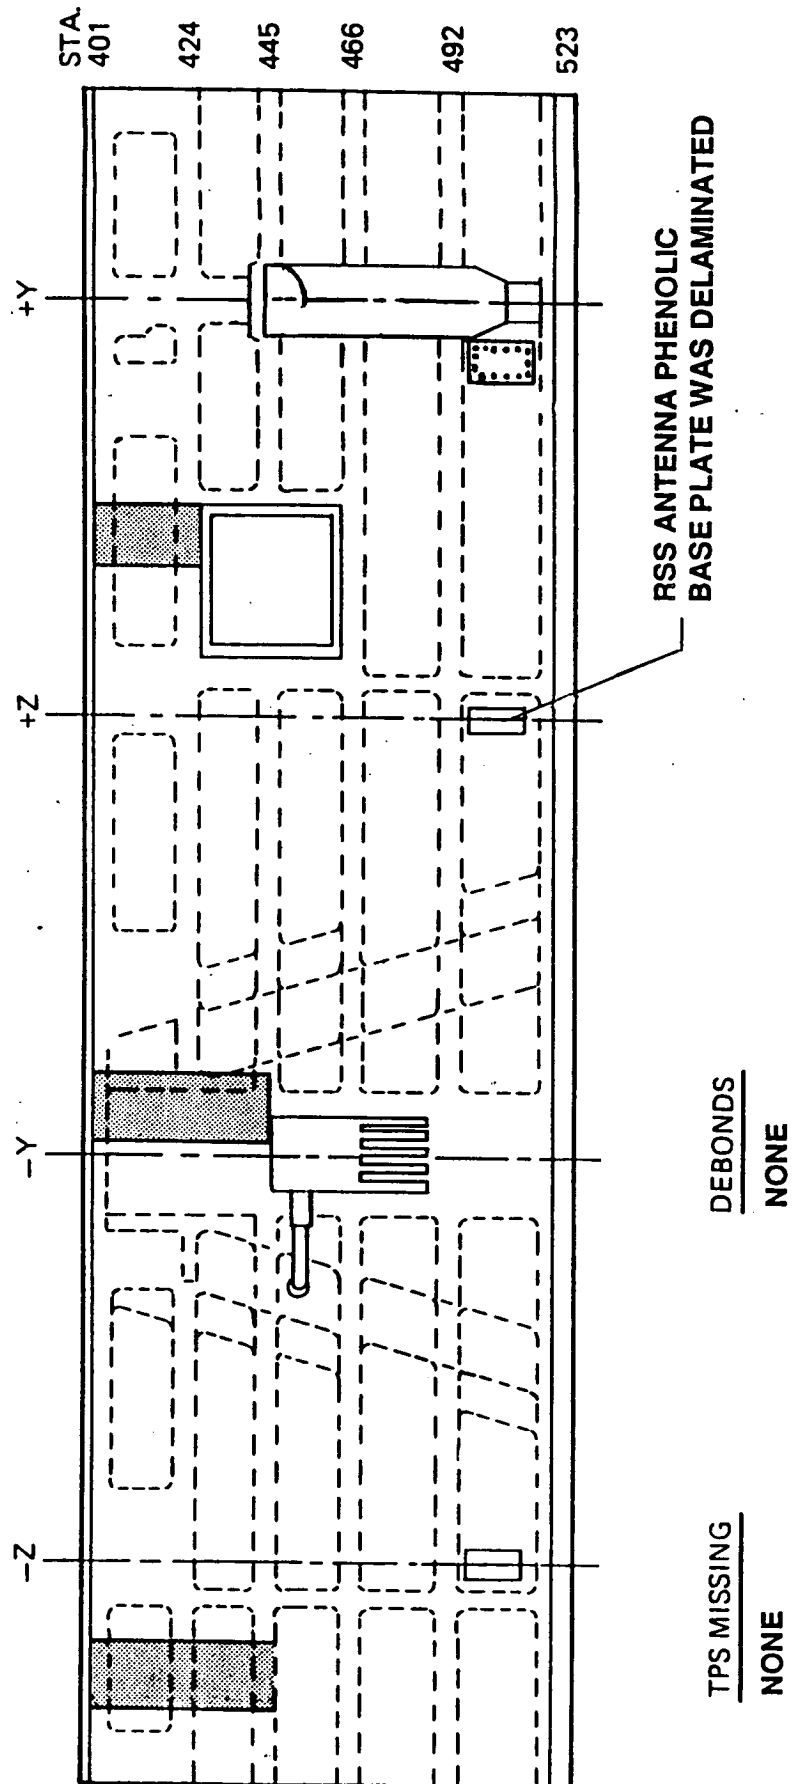
Figure 5. RIGHT SRB FWD SKIRT

The RH forward skirt exhibited no debonds or missing TPS. Both RSS antennae covers/phenolic base plates were intact, but the plate on the +Z antenna was delaminated. Minor blistering of the Hypalon paint occurred on the systems tunnel cover and around the ET/SRB attach point (Figure 5). No pins were missing from the frustum severance ring. The forward separation bolt and electrical cables appeared to have separated cleanly.

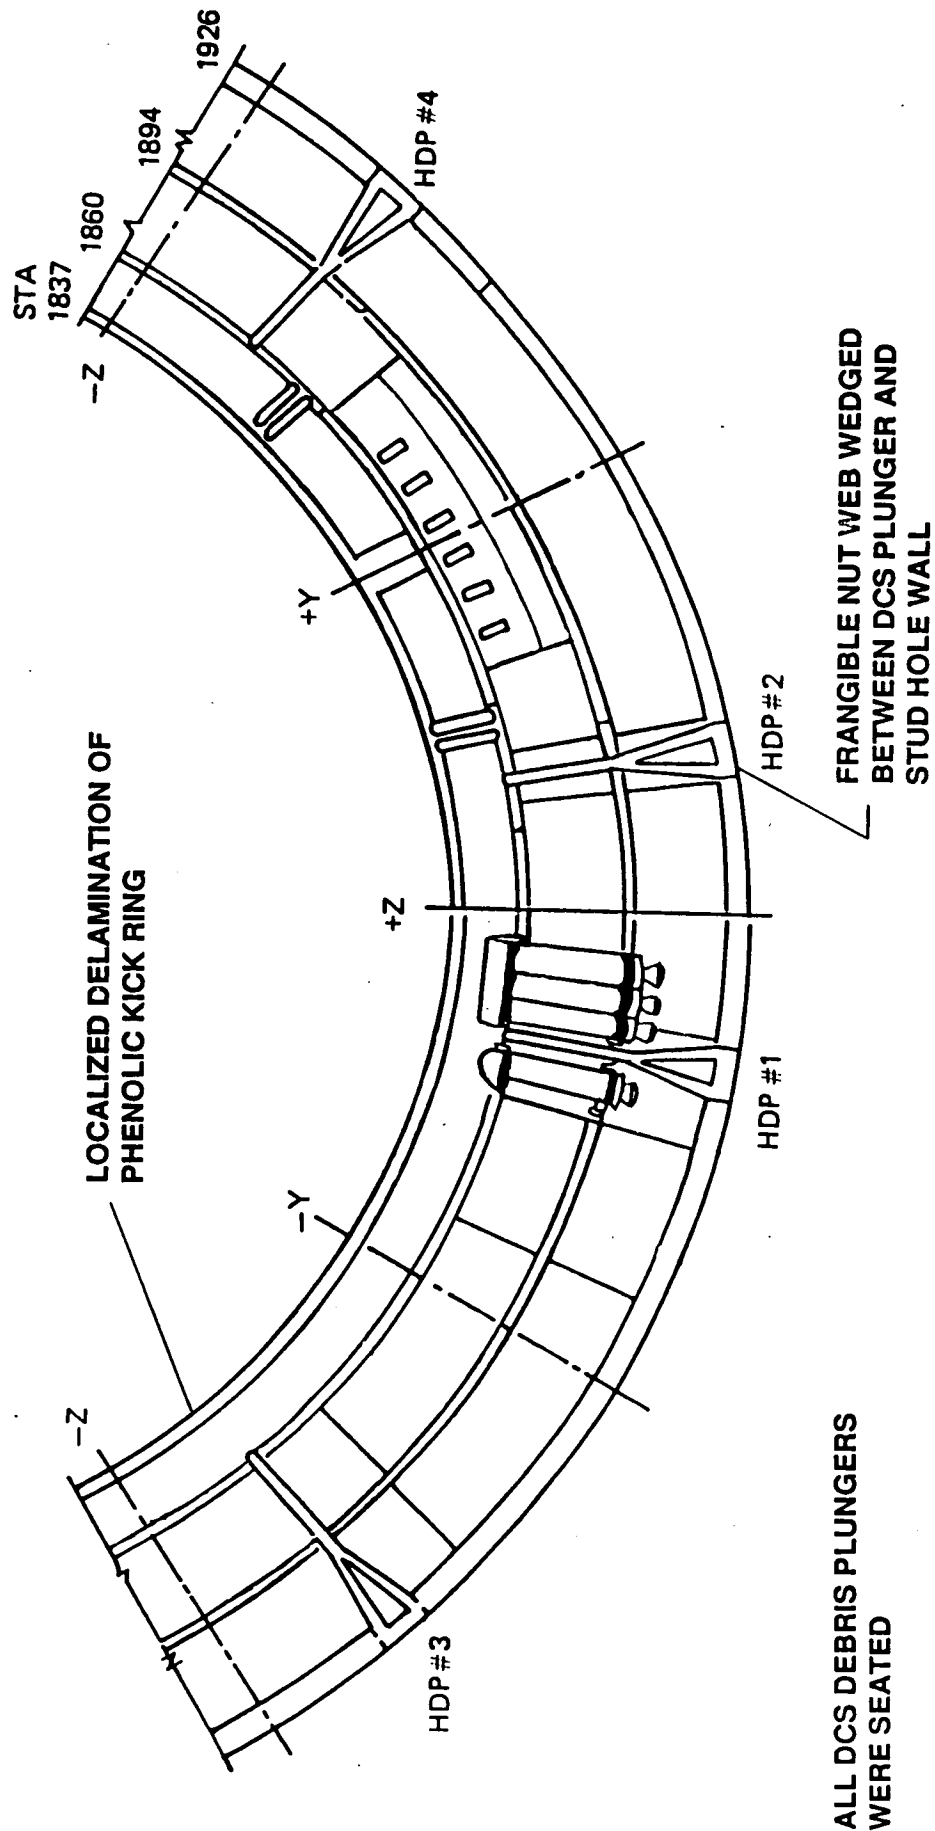
Figure 6. RIGHT SRB AFT SKIRT EXTERIOR TPS

The phenolic material on the kick ring was delaminated. The K5NA closeouts (protective domes) on the kick ring forward and aft fasteners had been eliminated. RTV-133 replaced the K5NA over the forward fasteners (Figure 6).

None of the aft skirt HDP EPON shim material was lost at lift off. Although seated, a frangible nut web was wedged between the HDP #2 DCS plunger and the stud hole wall. The other three Debris Containment System (DCS) plungers were seated properly.

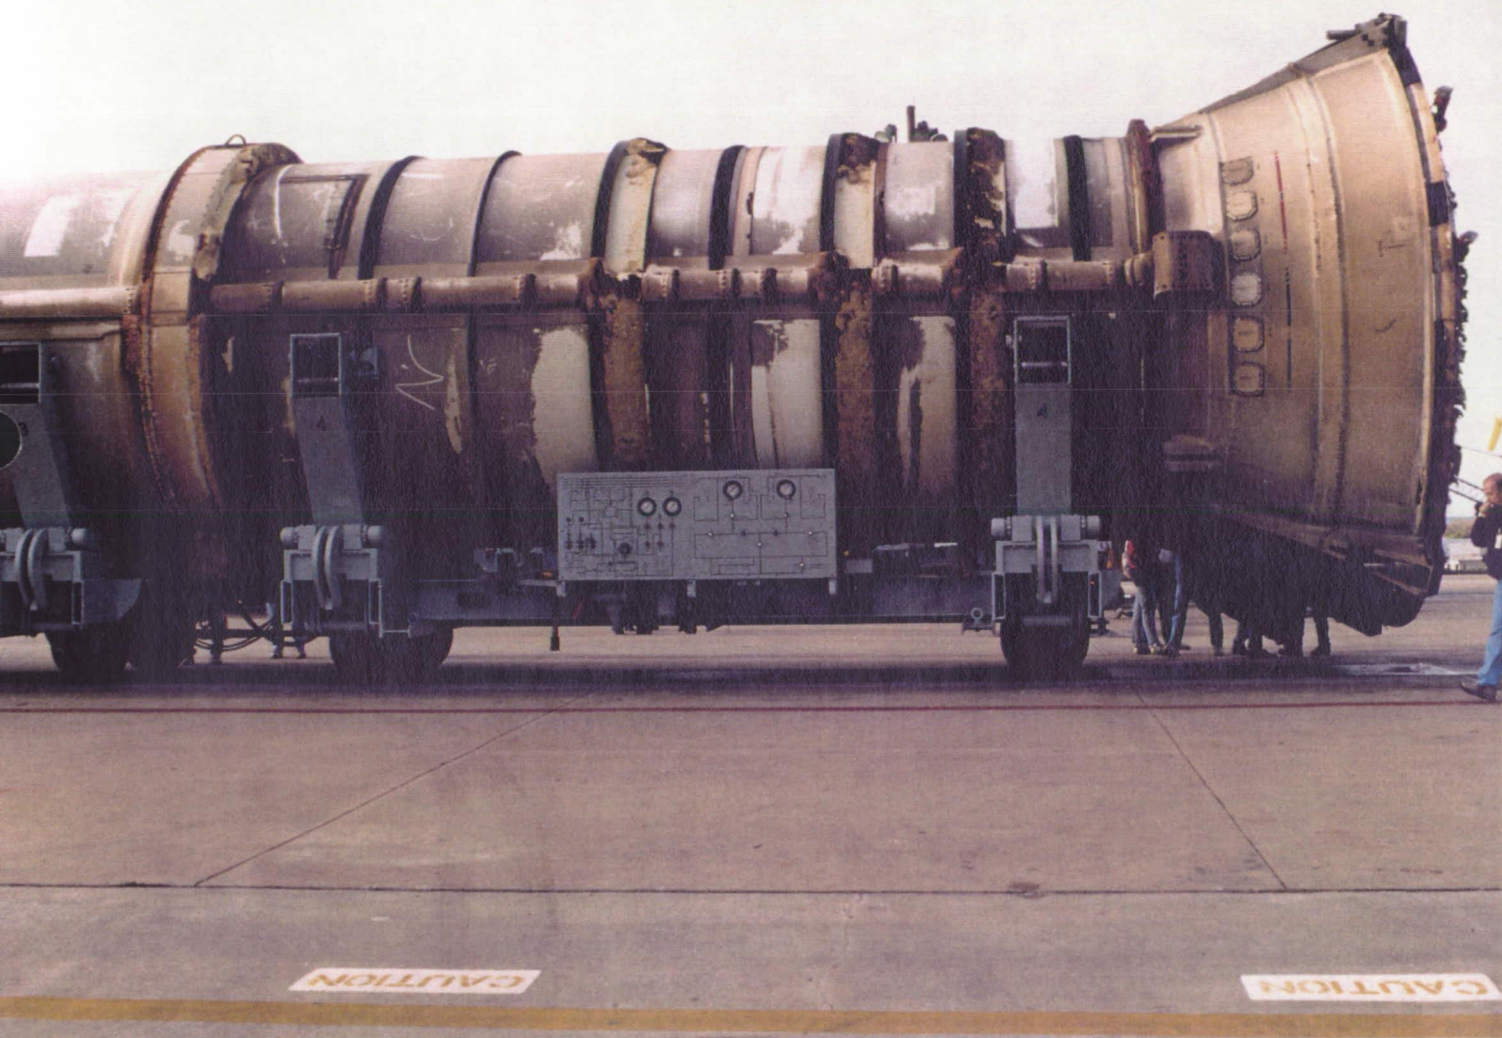
Several areas on the SRM segment cases exhibited missing paint and exposed metal substrate.

Post flight condition of the aft booster and aft skirt. The ET/SRB aft struts, ETA ring, IEA, and IEA covers appeared undamaged.

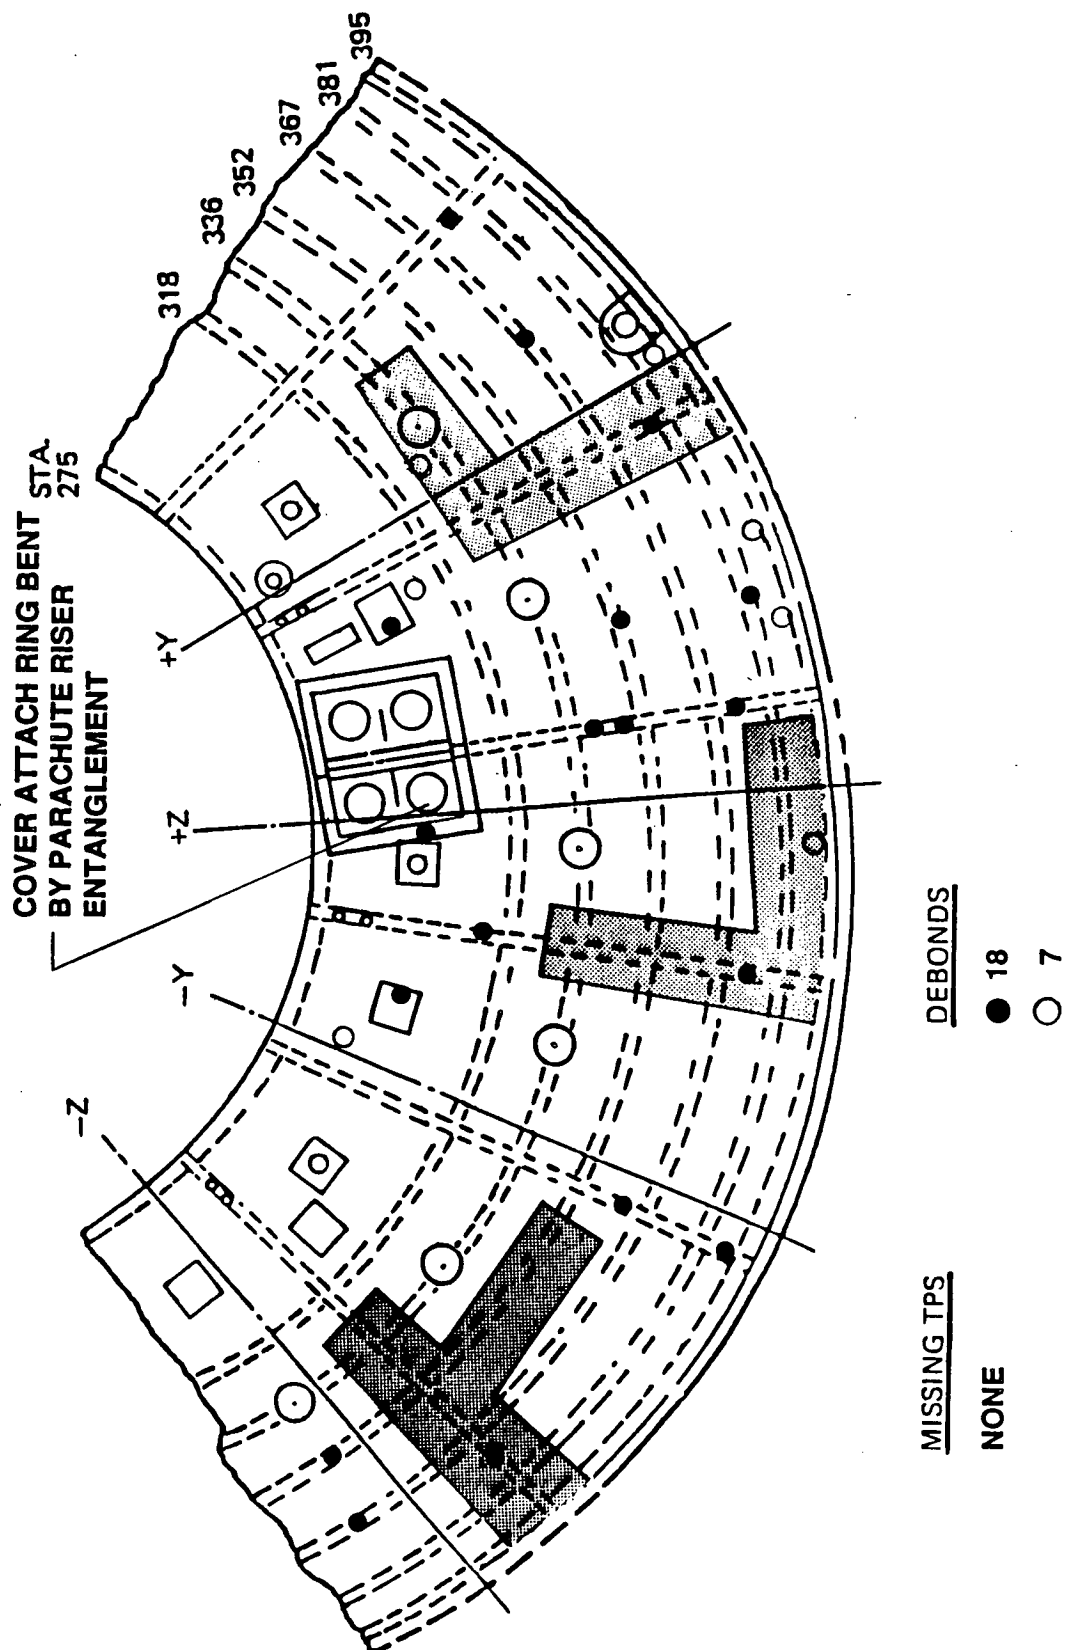
Figure 7. **LEFT SRB FRUSTUM**

The LH frustum was missing no TPS, but had 18 MSA-2 debonds over fasteners and seven acreage debonds (Figure 7). Minor localized blistering of the Hypalon paint had occurred along the 395 ring. The BSM aero heat shield covers were locked in the fully opened position, though the lower left cover attach ring had been bent by parachute riser entanglement.

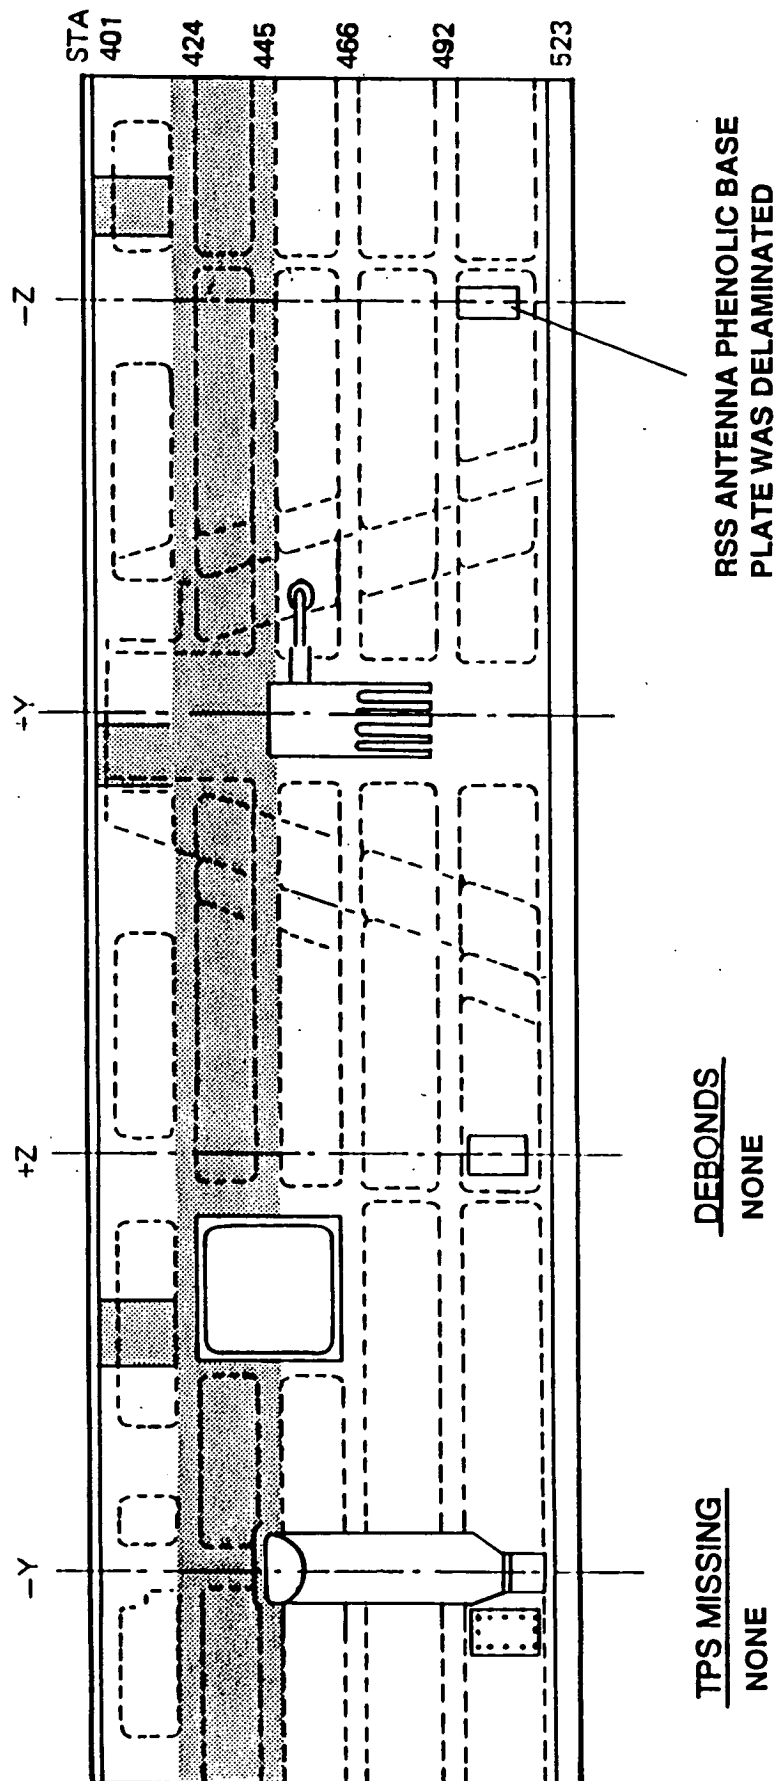
Figure 8. **LEFT SRB FWD SKIRT**

The LH forward skirt exhibited no debonds or missing TPS. The phenolic plates on both RSS antennae were intact, but the -Z plate was delaminated. Minor blistering of the Hypalon paint occurred near the ET/SRB attach point and on the systems tunnel cover (Figure 8). No pins were missing from the frustum severance ring. The forward separation bolt and electrical cables appeared to have separated cleanly.

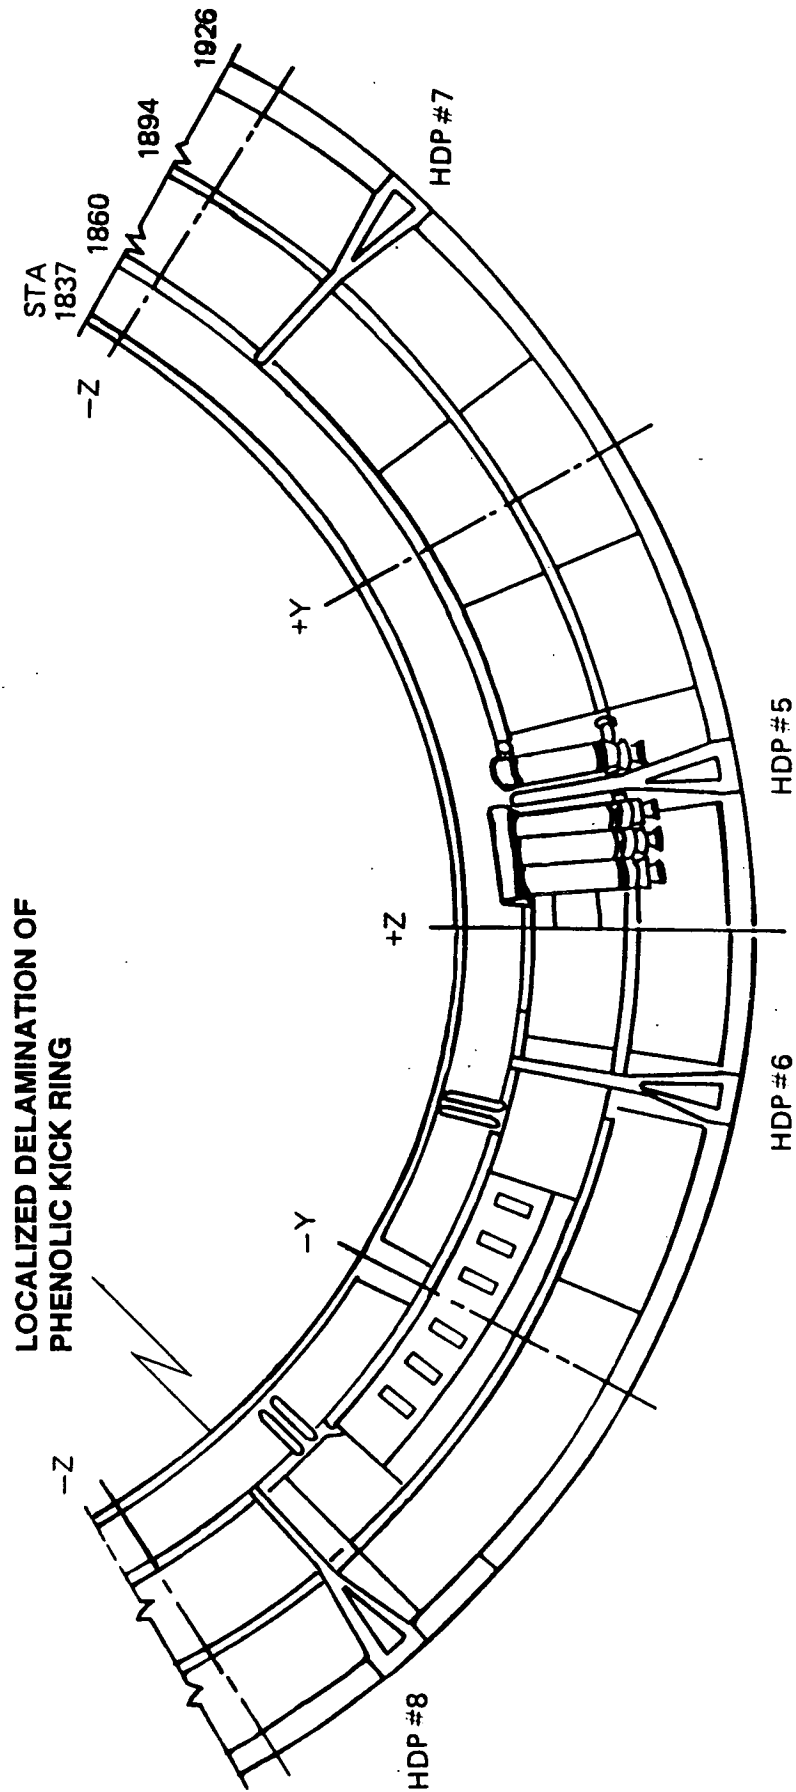
Figure 9. LEFT SRB AFT SKIRT EXTERIOR TPS

The phenolic material on the kick ring was delaminated in only localized areas. The K5NA closeouts (protective domes) on the kick ring forward and aft fasteners had been eliminated. RTV-133 replaced the K5NA over the forward fasteners (Figure 9)

All four Debris Containment System (DCS) plungers were properly seated. None of the aft skirt HDP EPON shim material was lost prior to water impact.

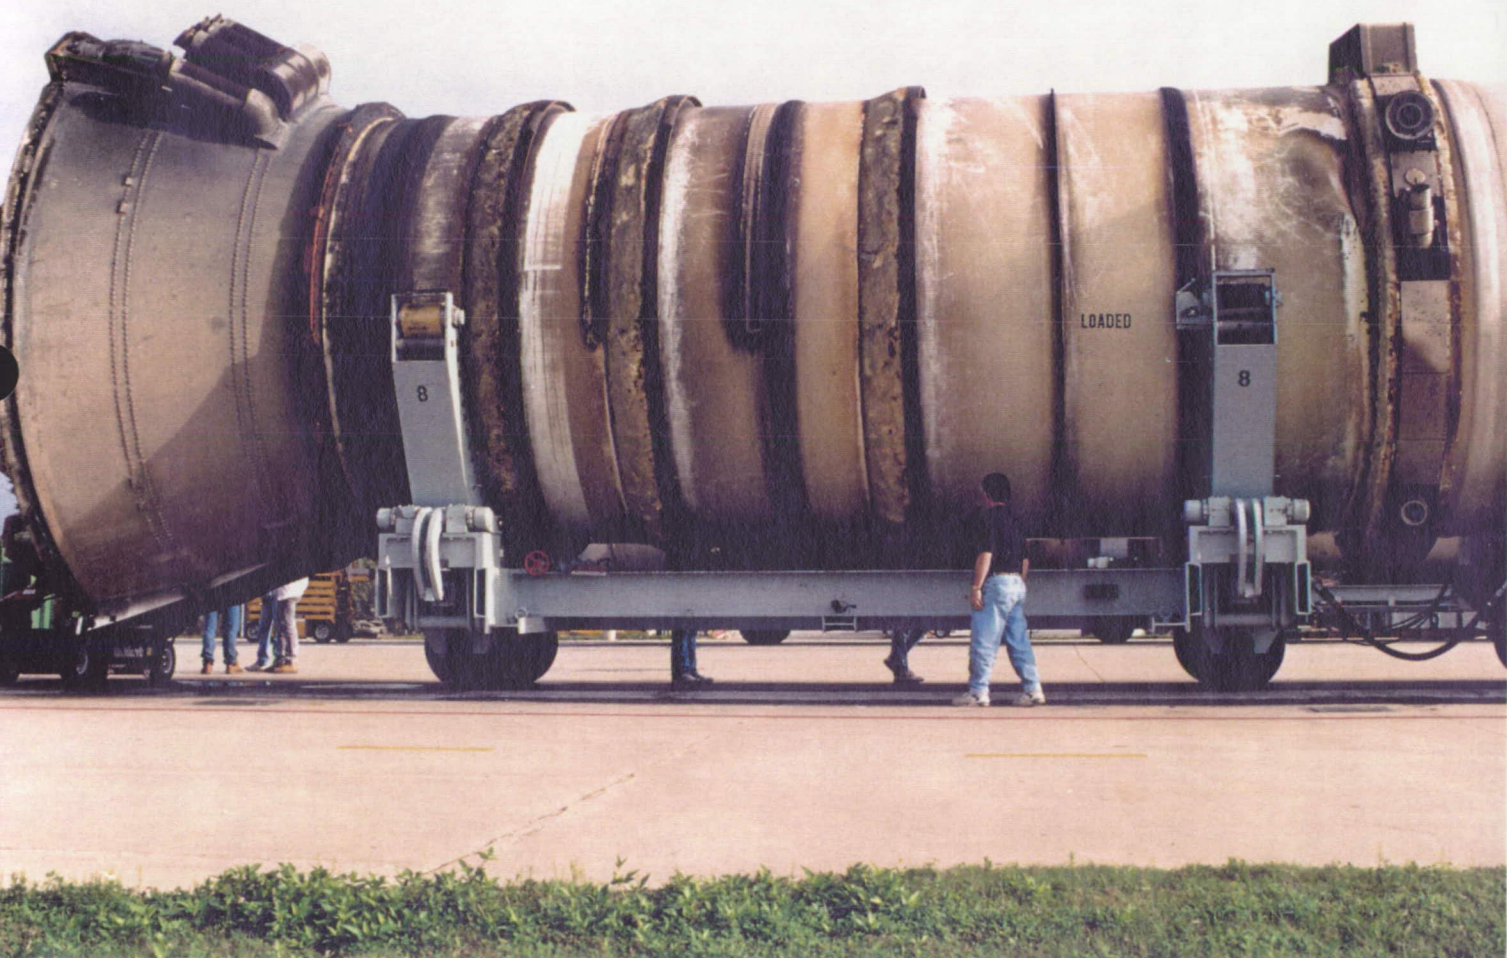
The LH forward skirt exhibited no debonds or missing TPS. The phenolic plates on both RSS antennae were intact. Minor blistering of the Hypalon paint occurred near the ET/SRB forward attach point.

Post flight condition of the aft booster and aft skirt. The ET/SRB aft struts, ETA ring, IEA, and IEA covers appeared undamaged.

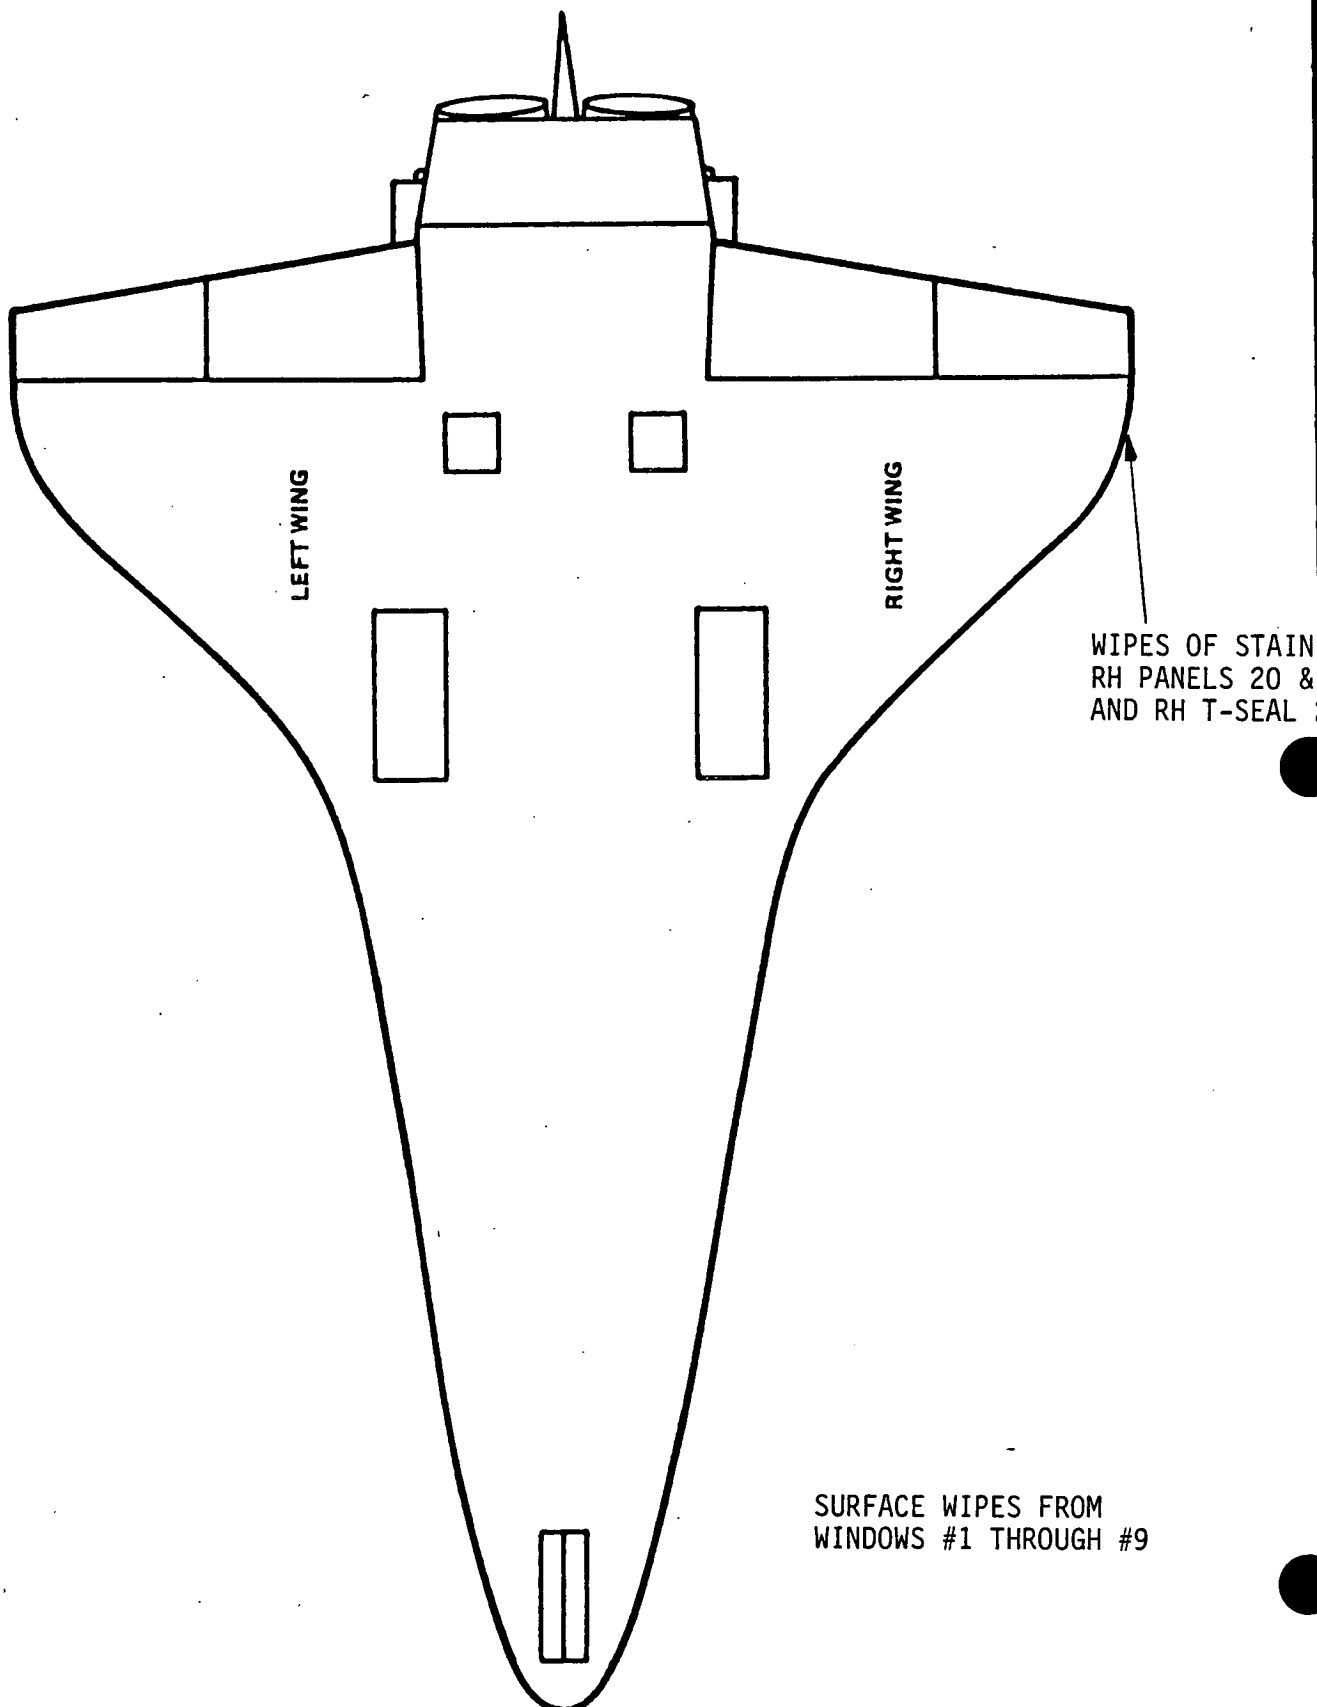
Figure 14. **CHEMICAL SAMPLE LOCATIONS**

Orbiter windows #3 and #4 exhibited moderate hazing and several streaks. Only a very light haze was present on the other forward facing windows. Surface wipes were taken from Windows #1 through #9 for laboratory analysis (reference Figure 14).

Wipes of stains on the right hand RCC panel #20, panel #21, and T-seal #21 were also taken for laboratory analysis (reference Figure 14).

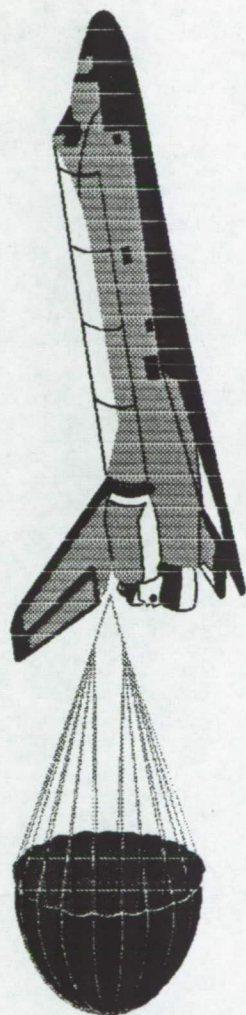
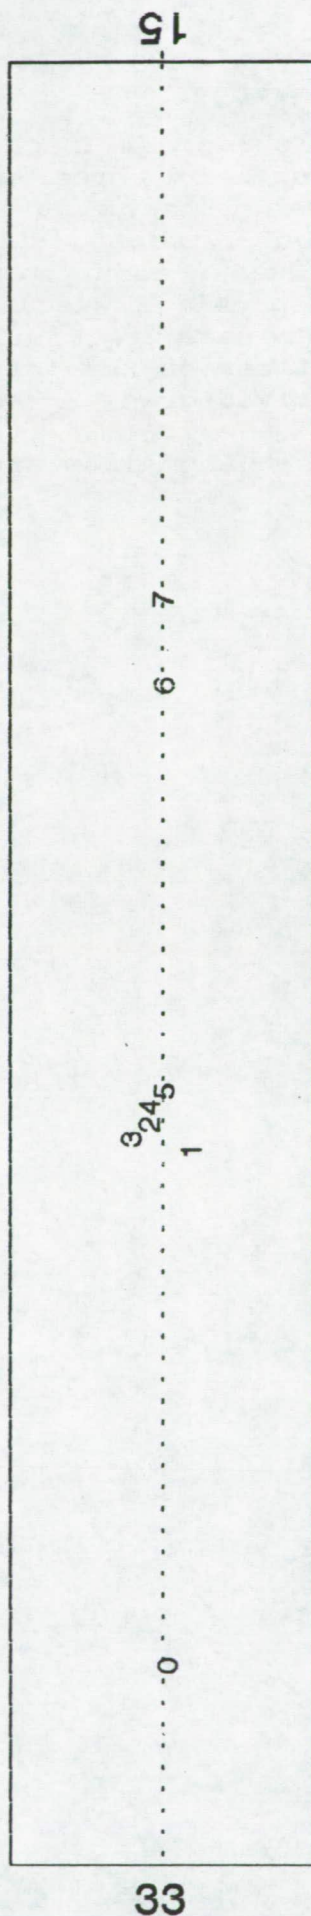
Figure 15.

This flight marked the sixth use of the Orbiter drag chute. Aside from the damage to the vertical stabilizer "stinger", the drag chute appeared to have functioned nominally. All drag chute hardware was recovered, appeared to be in good condition, and showed no signs of abnormal operation (reference Figure 15 for recovery locations).

- 0 (MLG TOUCHDOWN): 1536'
- 1 (MORTAR COVER): 5800', 28' R OF C/L
- 2 (SABOT): 5950', 18' L OF C/L
- 3 (DOOR): 5900', 25' L OF C/L
- 4 (PILOT CHUTE): 5975', 18' L OF C/L
- 5 (NLG TOUCHDOWN): 6247'
- 6 (MAIN CHUTE): 9600', ON C/L
- 7 (WHEEL STOP): 10259'

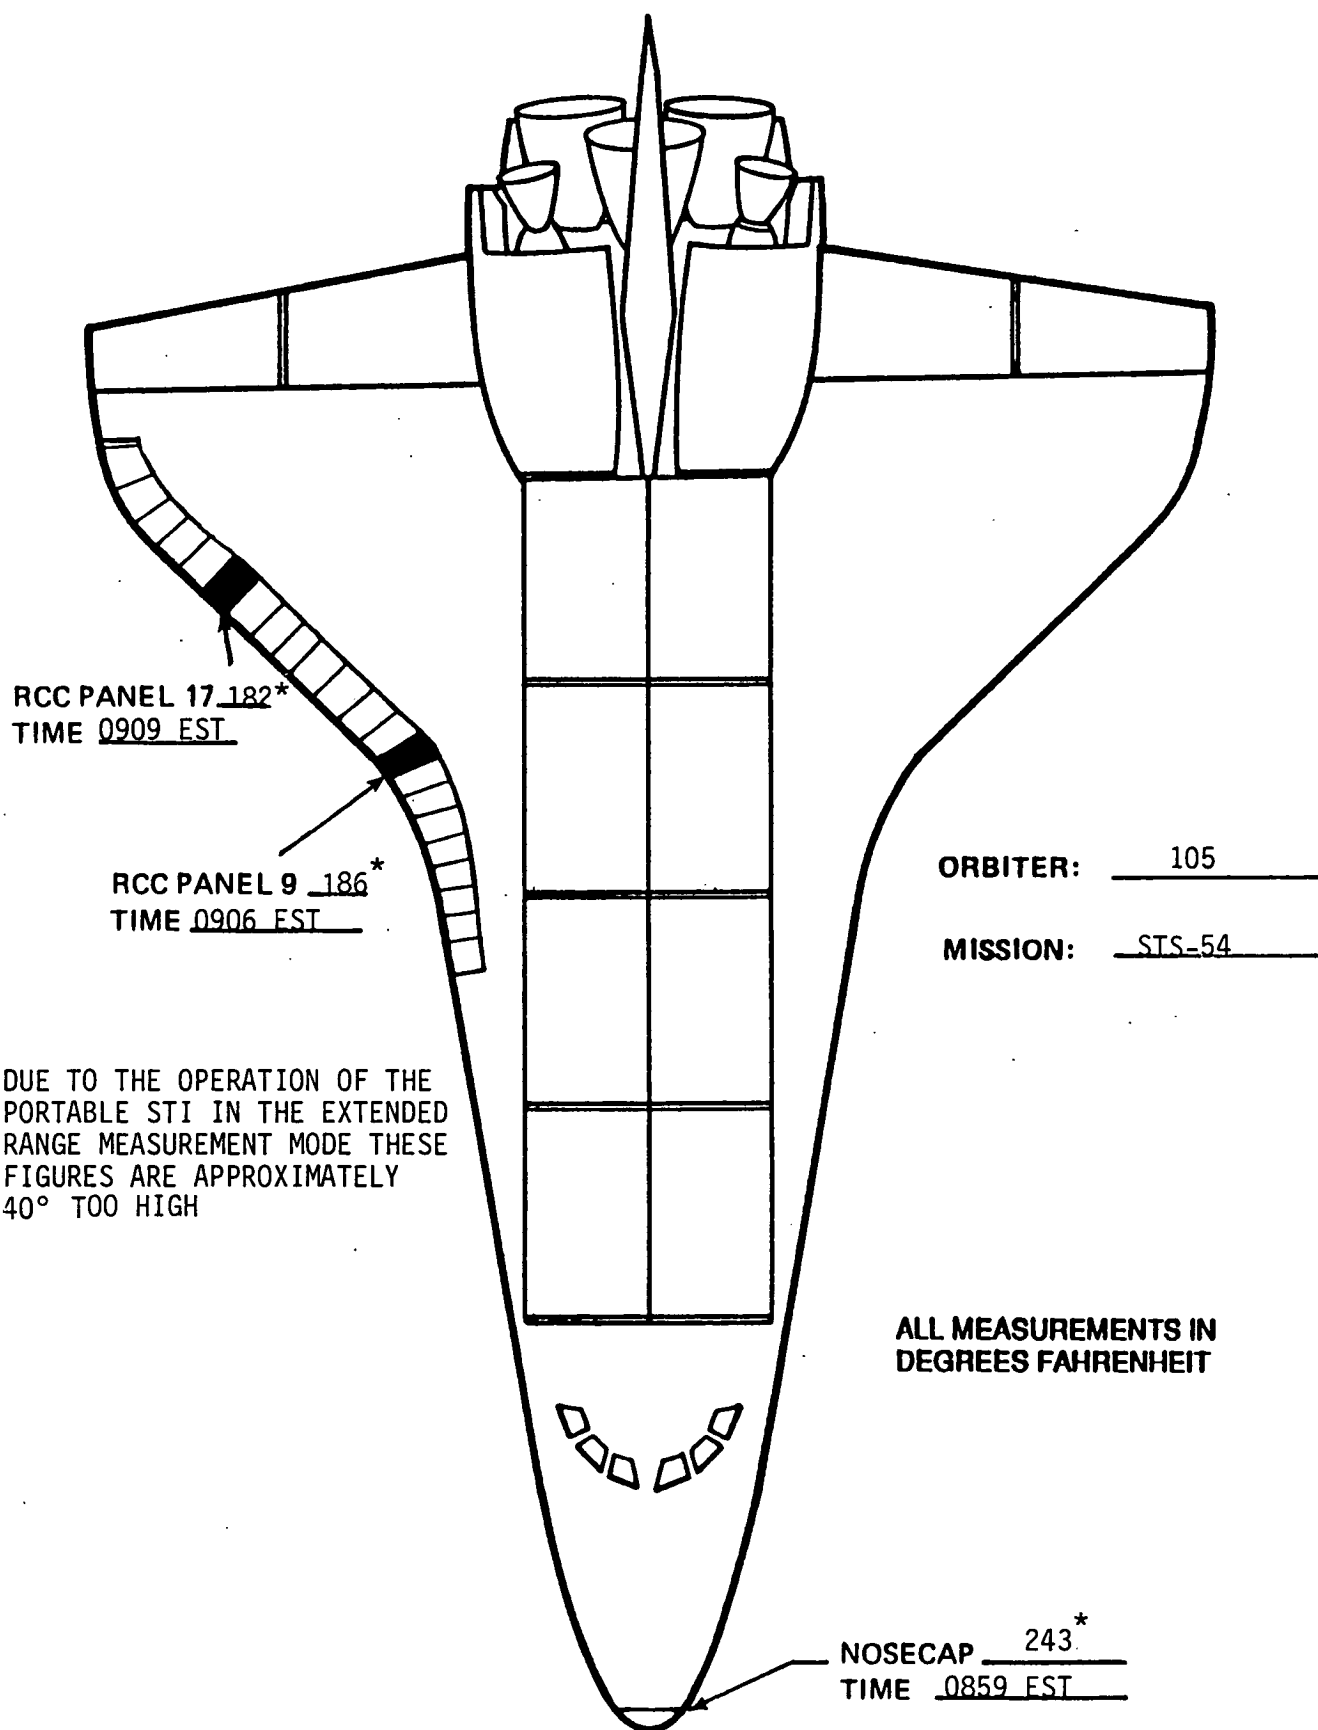
Figure 16. **STS-54 RCC TEMPERATURE MEASUREMENTS AS  
RECORDED BY THE SHUTTLE THERMAL IMAGER**

A portable Shuttle Thermal Imager (STI) was used to measure the surface temperatures of three areas on the Orbiter (per OMRSD V09AJ0.095). Twenty-one minutes after landing, the Orbiter Reinforced Carbon-Carbon (RCC) nose cap was 243 degrees Fahrenheit (F). Twenty-eight minutes after landing the RH wing leading edge RCC panel #9 was 186 degrees F, and panel #17 was 182 degrees F (reference Figure 16). Due to the use of an extended range filter on the instrument, these measurements are approximately forty degrees F too high.
